***FORMER
WILLIAMS AIR FORCE BASE***

**Site ST012
Former Liquid Fuels Storage Area
Remedial Action**

**BCT Meeting
24 August 2016**

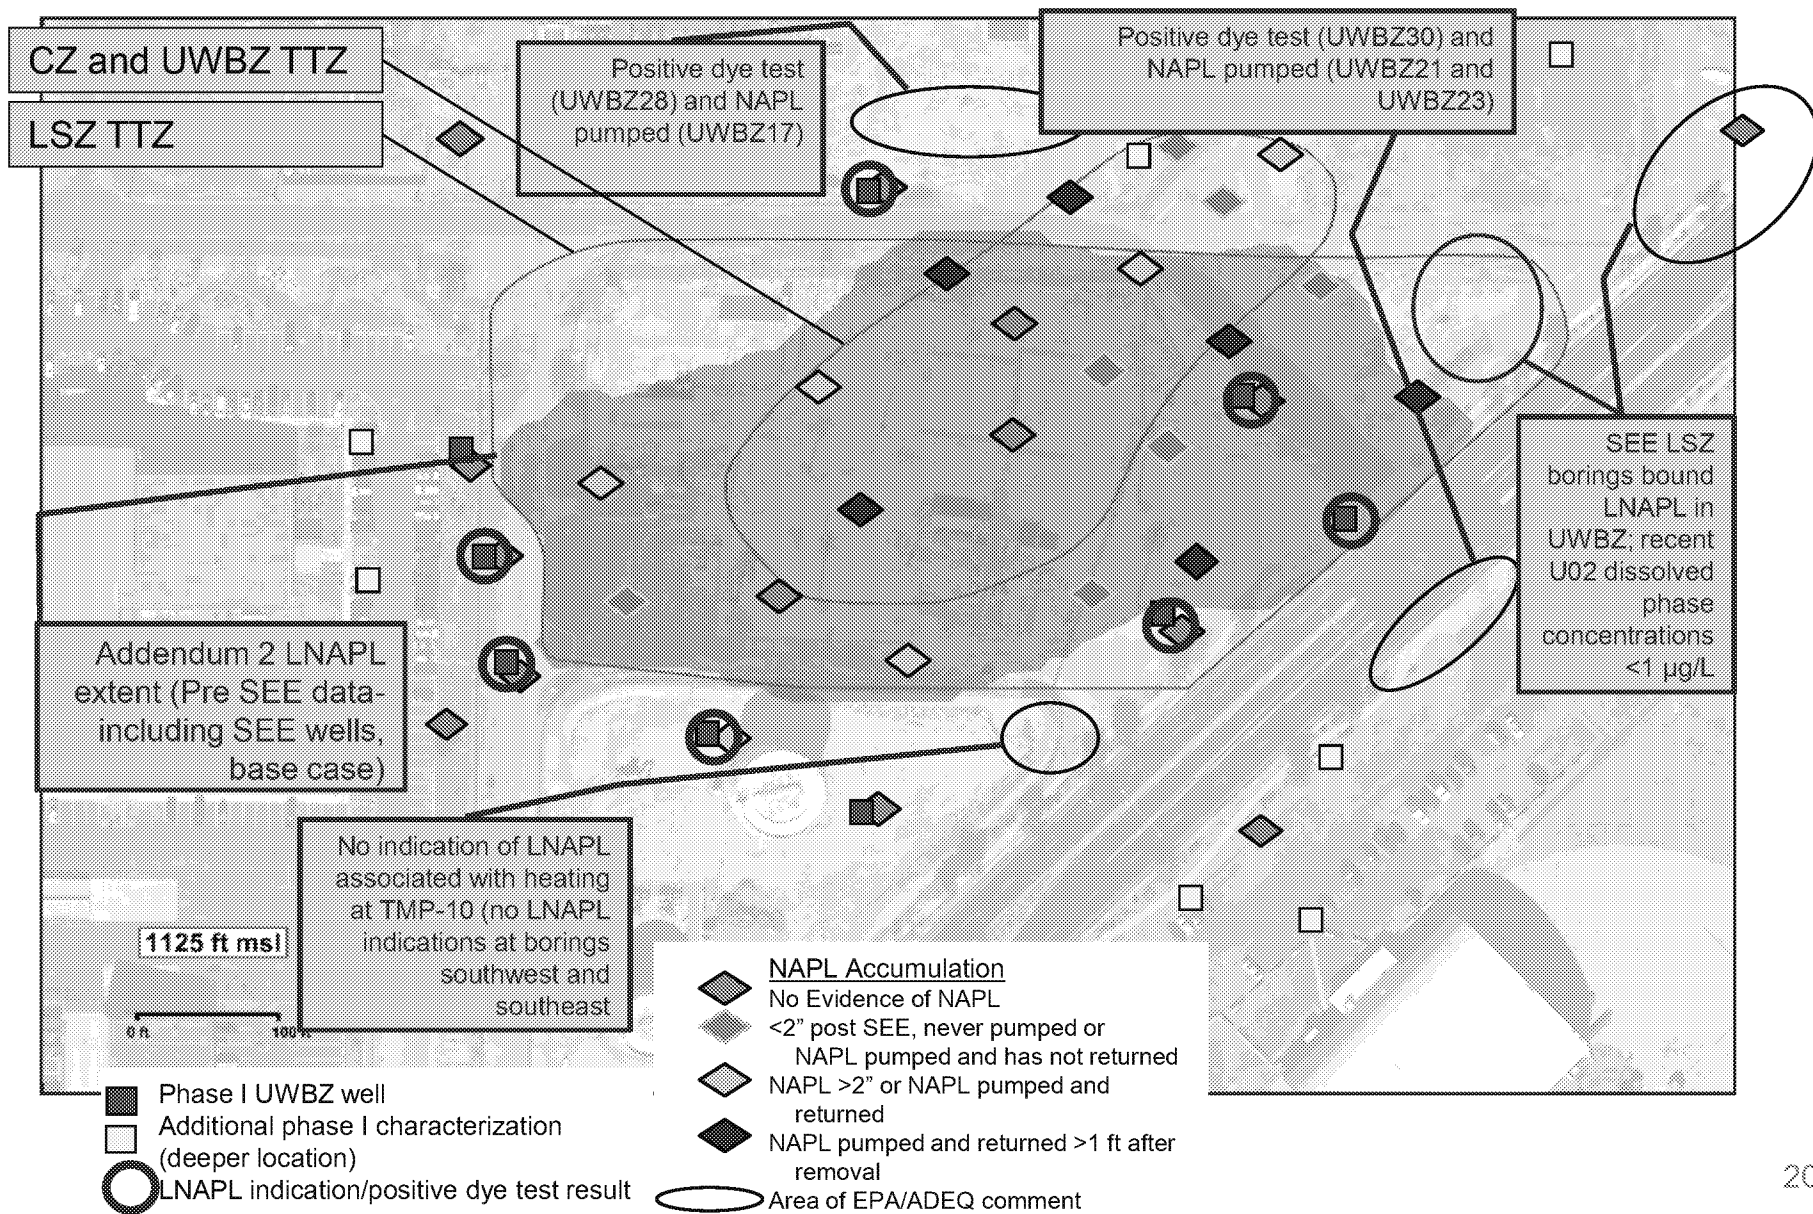
Evaluation of UWBZ LNAPL Characterization

Summary of Phase 1 LNAPL Data

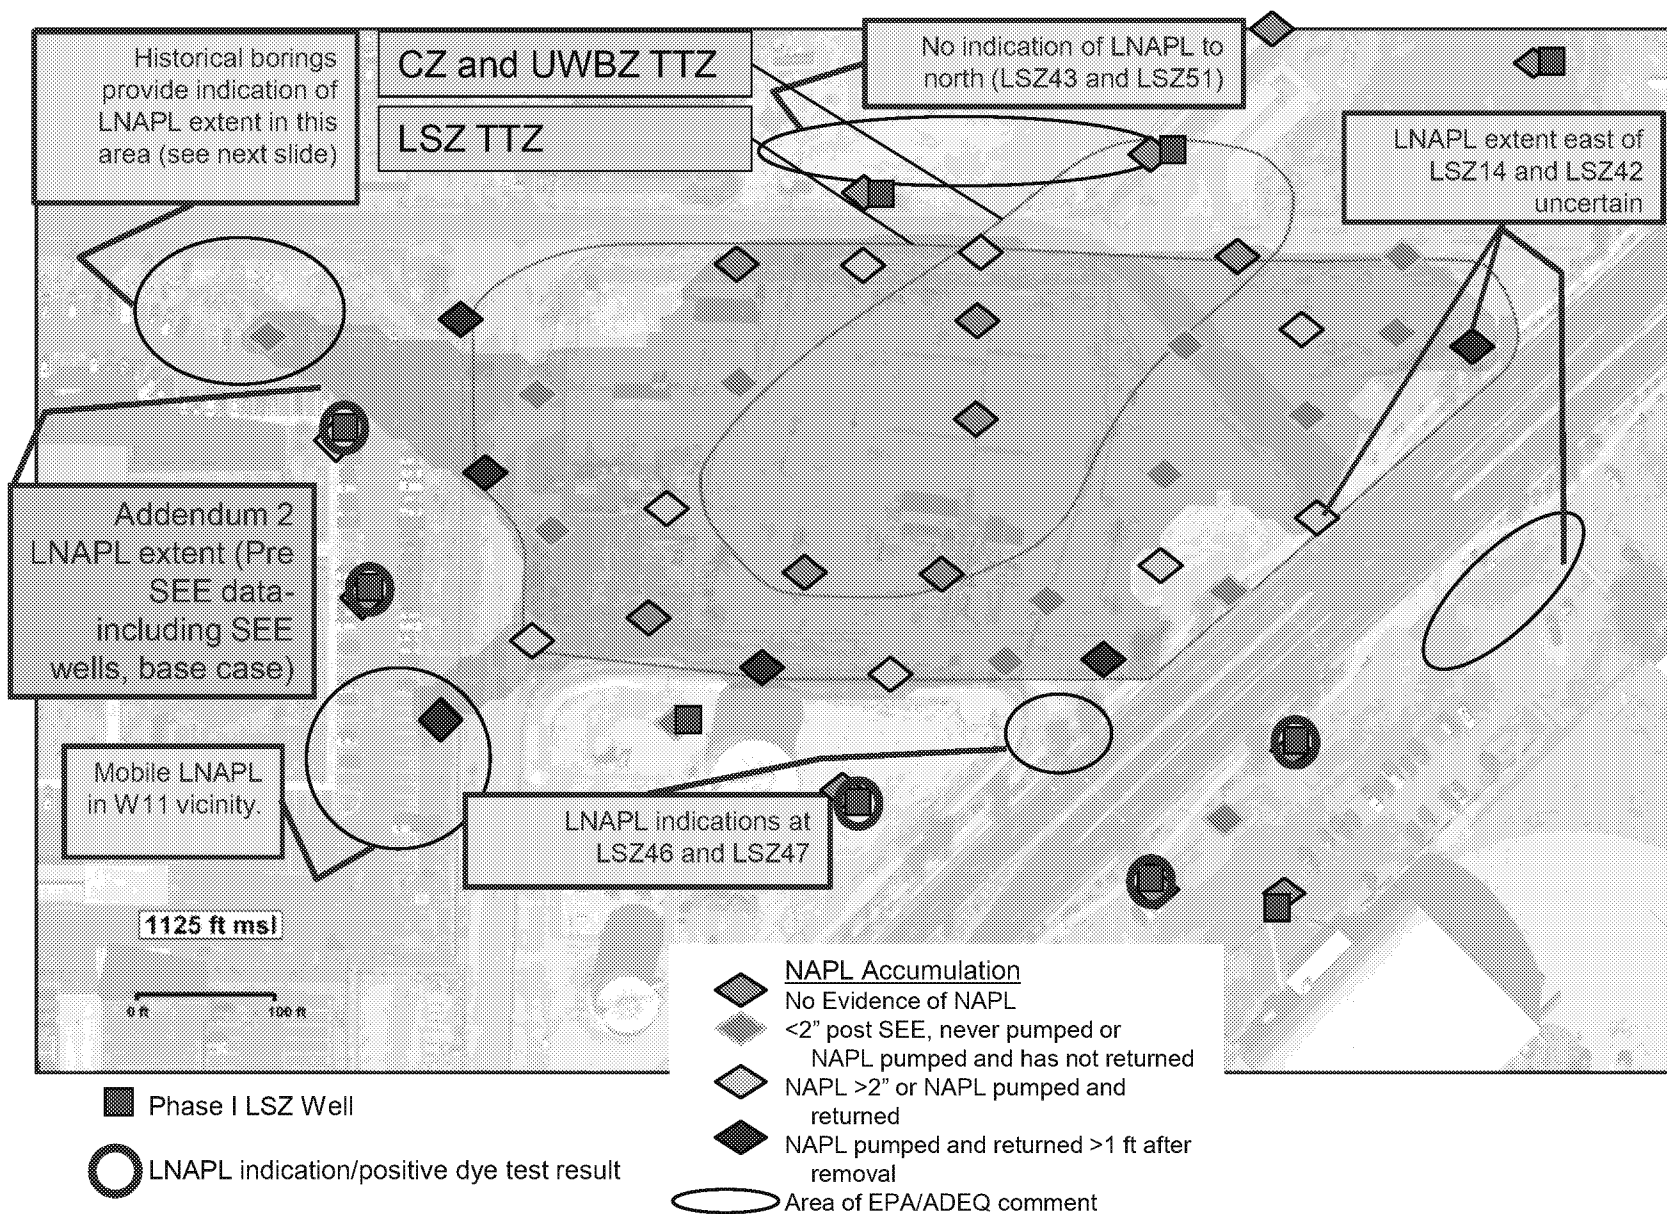
Evaluation of LSZ LNAPL Characterization

Summary of Phase 1 LNAPL Data

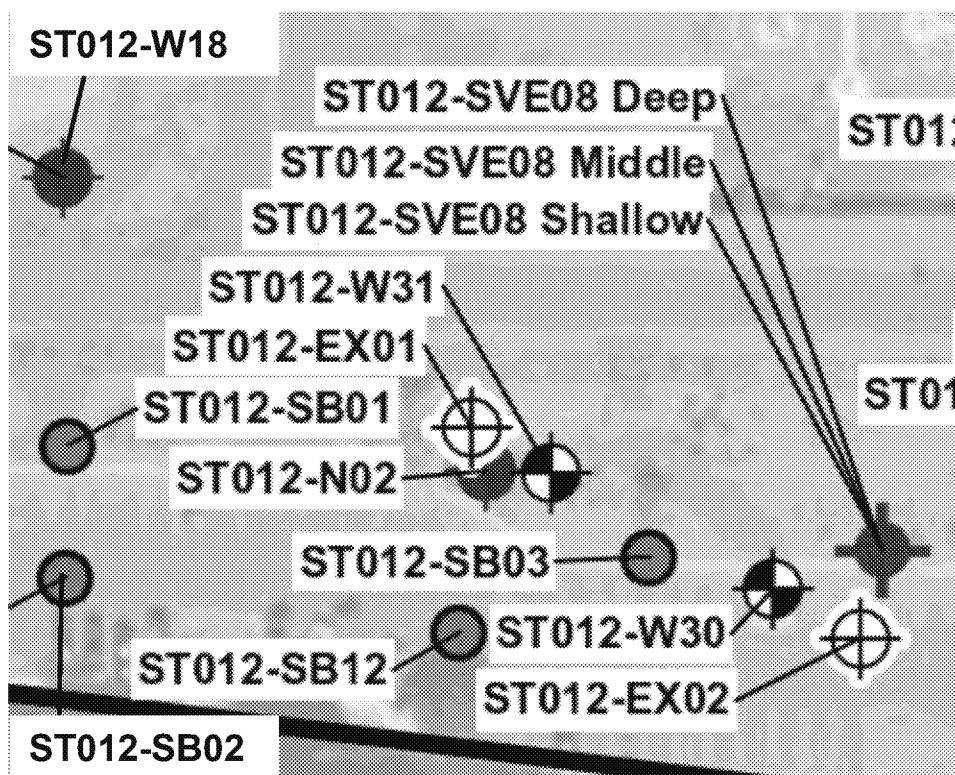
W-30 Area (Historical Borings)

- SB01
 - No indication of NAPL to 220 ft bgs
 - Odor and 29 mg/kg TPH at 220 ft bgs
- SB02
 - No indication of NAPL to 220 ft bgs
 - 17 mg/kg TPH at 220 ft bgs
- SB03
 - Likely NAPL at 215 to 220 ft bgs
 - Odor, benzene 20 mg/kg, TPH 3,200 mg/kg
- SB12
 - Possible NAPL at 212 to 217 ft bgs
 - Visible staining, odor, but soil analysis not available
- N02
 - Likely NAPL at 216 to 222 ft bgs
 - Strong odors, PID >1,000 ppm
- W18
 - Boring log not available
- W31
 - Boring log not available

LNAPL extent extends west past SB12 and N02 but is bounded by SB01 and SB02 locations.

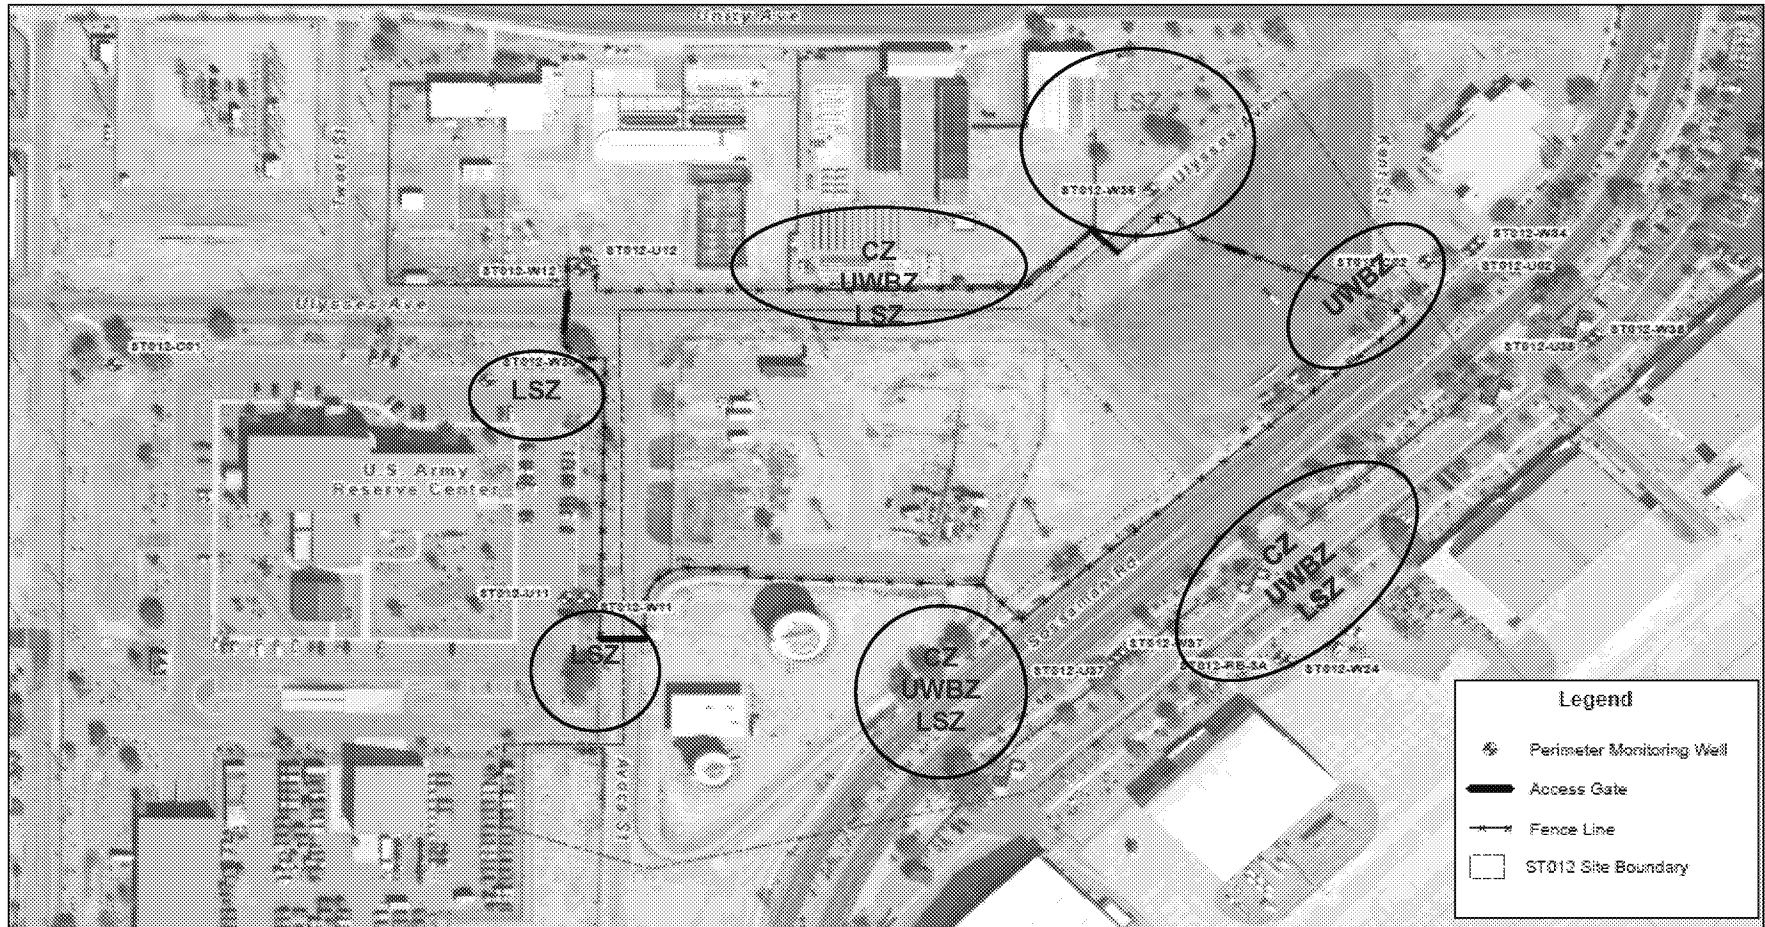
Site ST012 EPA/ADEQ Concerns for LNAPL and Groundwater (Benzene) Characterization

Red – LNAPL and dissolved phase

Green – dissolved phase

Blue – LNAPL

Area of EPA/ADEQ comment

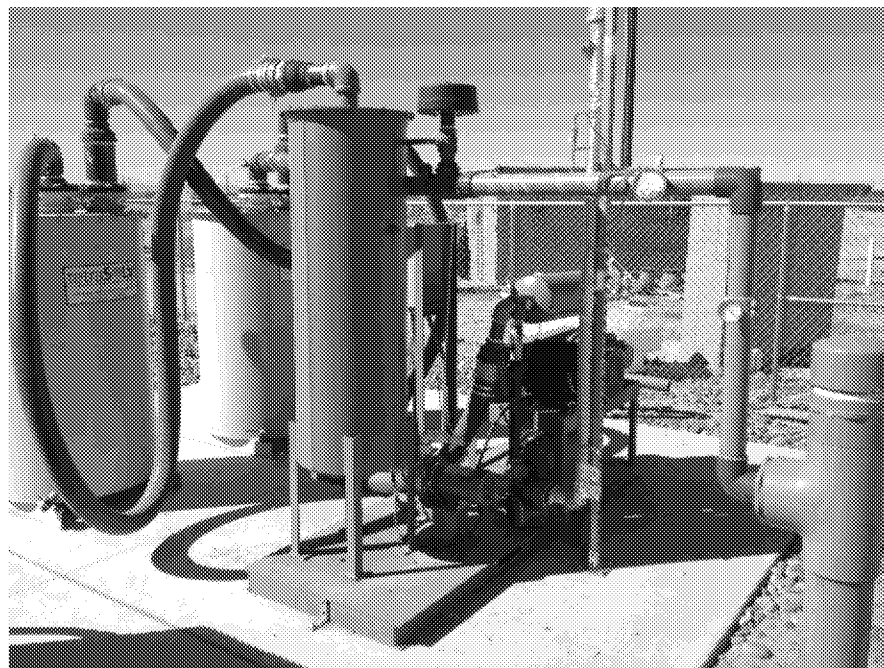
Former AST SVE System Update

- Began operation 9 Sep 2014 to Nov 2015 (15 months of continuous operation)
- Shutdown for rebound testing Nov 2015-Jan 2016
- SVE system restarted and operated Jan 2016 thru Apr 2016
- Analytical data (May 2016) indicates TCE and PCE concentration remained below soil vapor goals for groundwater protection (SVSLs) in all SVE wells and VMPs except TCE in SVE6-D (5 mg/m^3 vs 2 mg/m^3)
- All shallow wells TCE and PCE remain below soil vapor goals for indoor vapor intrusion
- SVE system shutdown in May 2016. SVE6-D connected to IWAS system
- 93.6 pounds of TCE and PCE removed by SVE during entire operational period

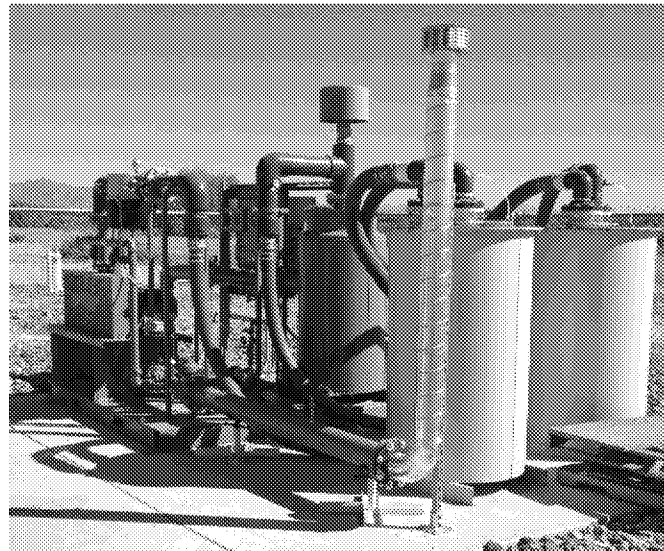
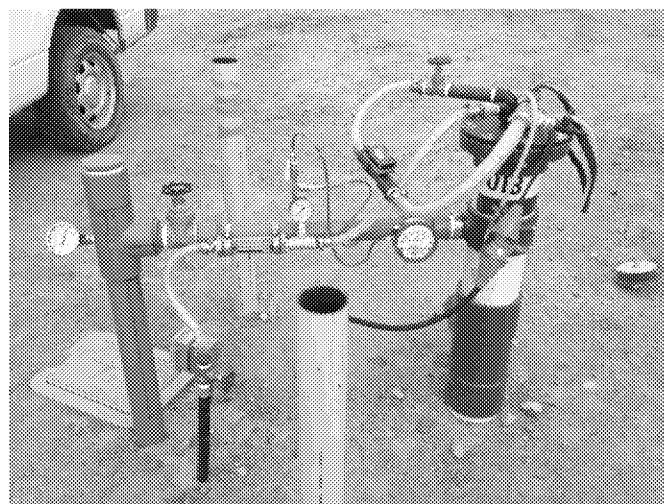
LF01-W17 Area IWAS System Update

- Began operation 29 Aug 2014 (approximately 22 months of operation)
- Average 99% operational uptime for reporting period
- TCE and PCE concentrations in extracted vapor are 640 and 120 micrograms per cubic meter ($\mu\text{g}/\text{m}^3$), respectively (Jul 2016); extracted vapor concentrations remain low. Air sparging shut down in Aug 2015 to increase soil gas mass removal (extracted vapor concentrations higher without air sparging)
- SVE 6D connected to IWAS system in May 2016
- Estimated 8.7 pounds of TCE and PCE removed by vapor extraction; 0.7 pounds since 8 Jul 2016
- Additional oxidant injection and recirculation scheduled in Aug 2016 at W30-M
- All remediation wells operating

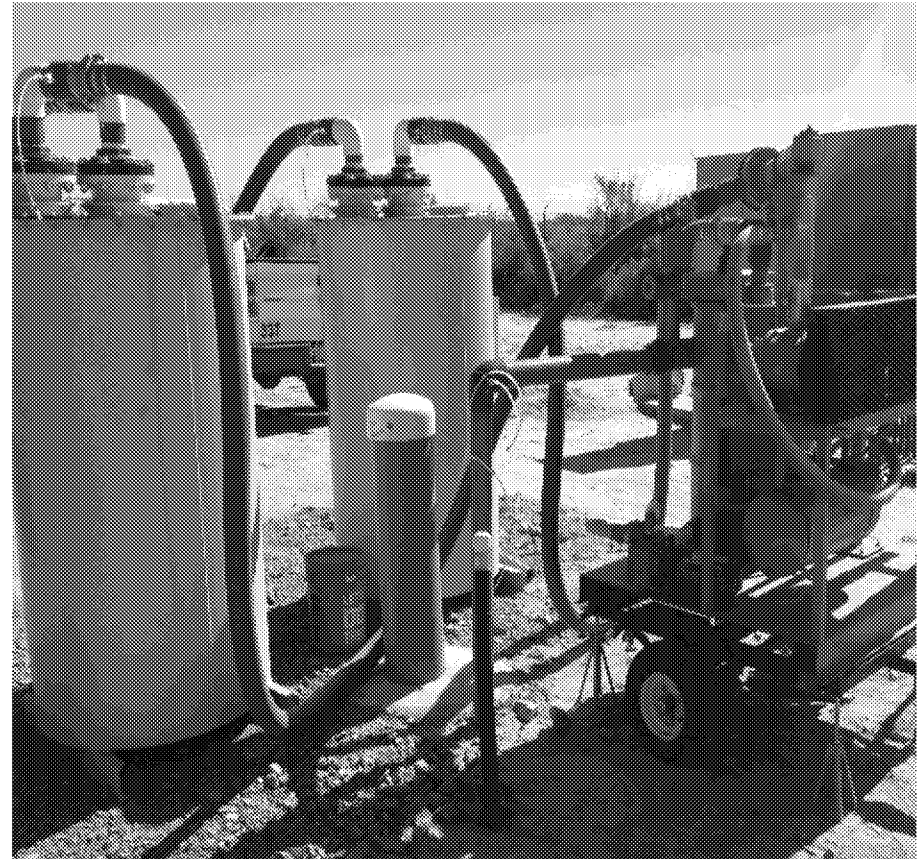
Southeast Landfill SVE System Update

- Began operation 12 Sep 2014 (15 months of continuous operation)
- Shutdown for rebound testing Nov 2015-Jan 2016
- SVE system restarted and operated Jan 2016 thru Apr 2016
- Analytical data (Jun 2016) indicates TCE and PCE concentration remained below soil vapor goals (SVSLs) for vapor intrusion in all shallow SVE wells and VMPs
- Analytical data (Jun 2016) indicates PCE concentration slightly above soil vapor goals (SVSLs) for groundwater protection in SVE-7M and SVE-7D (6.2 mg/m³ and 8.2 vs 3.6 mg/m³), respectively.
- 36.9 pounds of PCE and TCE removed by SVE during entire operational period

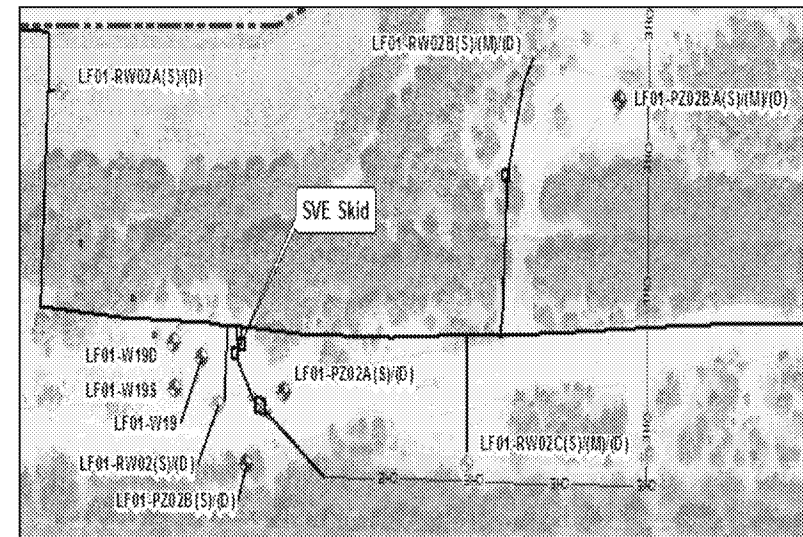
Southern Area Oxidant Injection

- Began operation 15 Sep 2014 (approximately 22 months of operation)
- Field screening of residual oxidant ongoing
- Last injection completed week of 27 Feb 2016 at LA06-S and W19-S
- Oxidant concentrations range from 1 to 125 mg/L in LF01-W19 area and 1 to 200 mg/L in LF01-W17 area

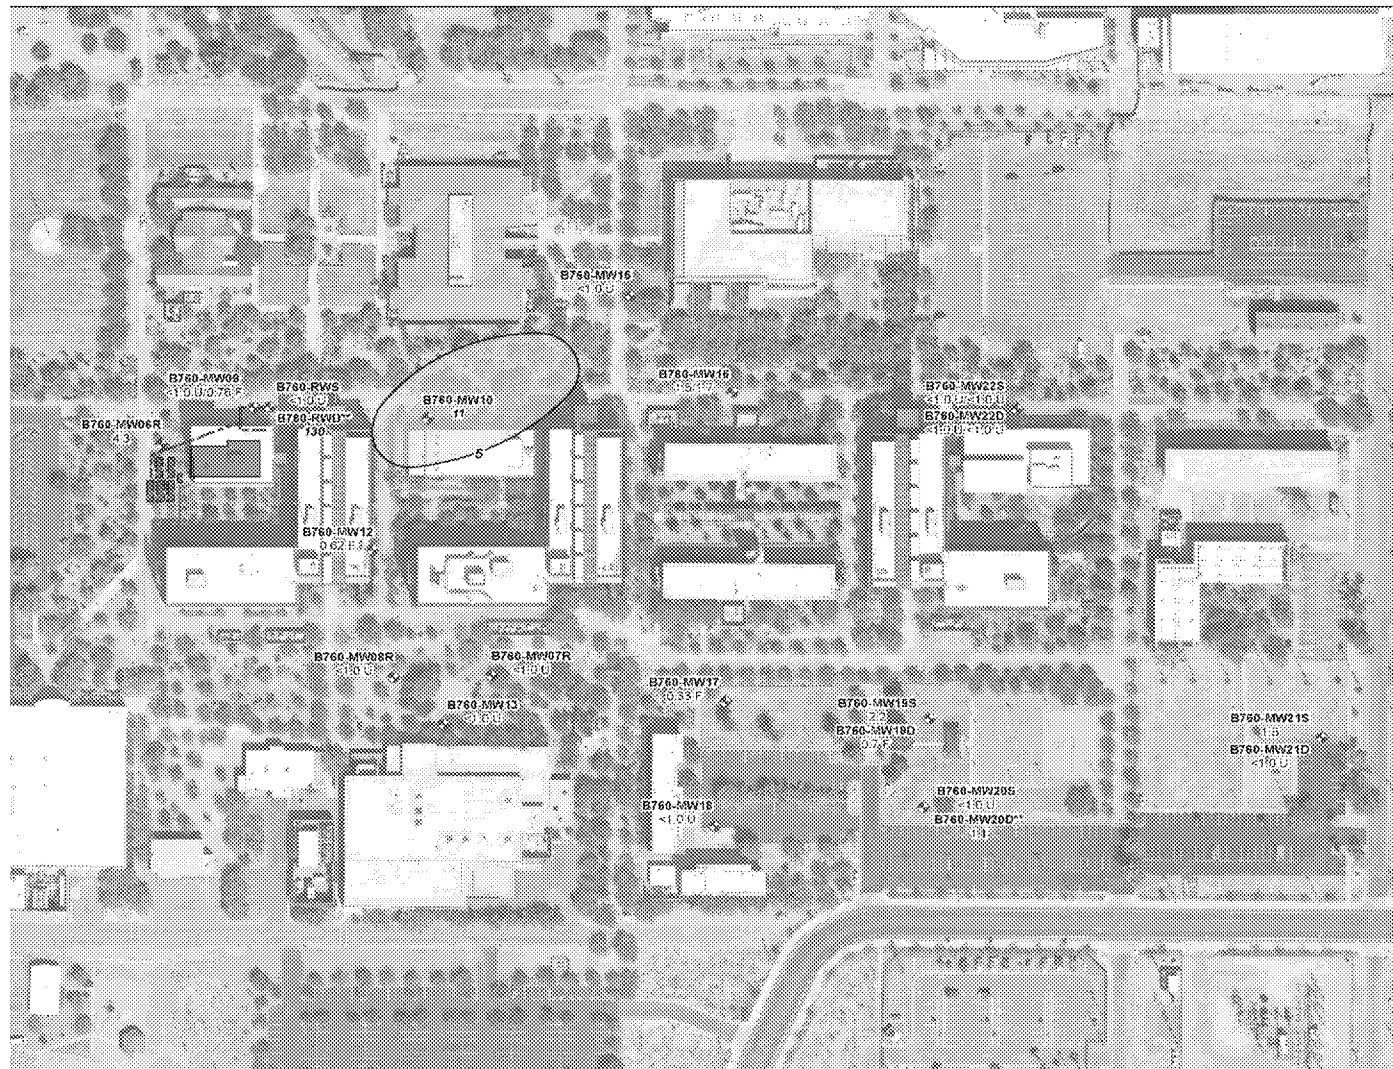
FIGURE 3-4	Job No.: 9101150001 Date: 11/15/2015 Scale: 1" = 140'	amtec foster white
---------------	---	--------------------------

ST035 1,2-DCA Concentrations
in Groundwater
November 2015
